**WELCOME TO  
DOCTOR HOUSE  
CARDIO-VASCULAR CENTRE**

**Long Standing  
Blockage of the Left  
Iliac vein**

**Due to  
Deep Vein  
Thrombosis  
in the Past**

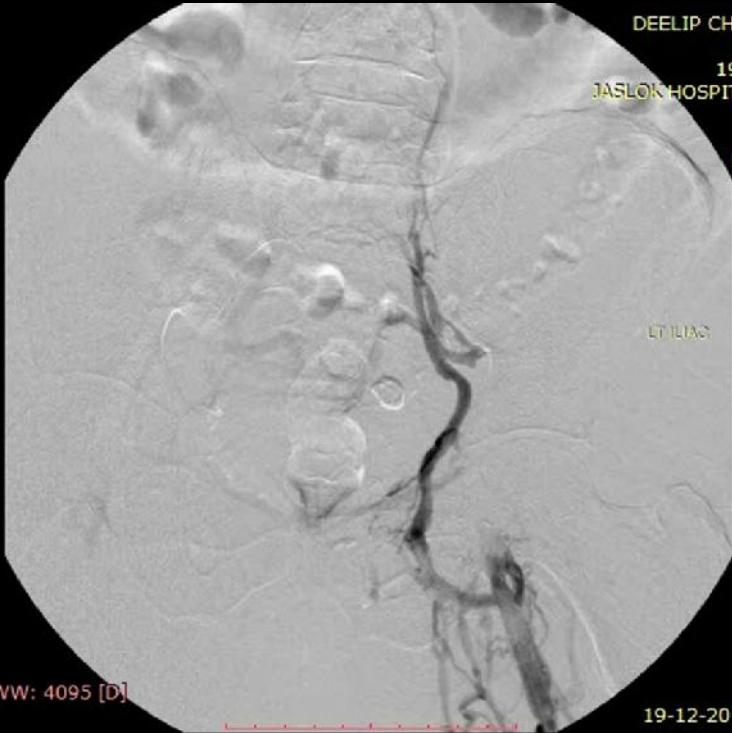
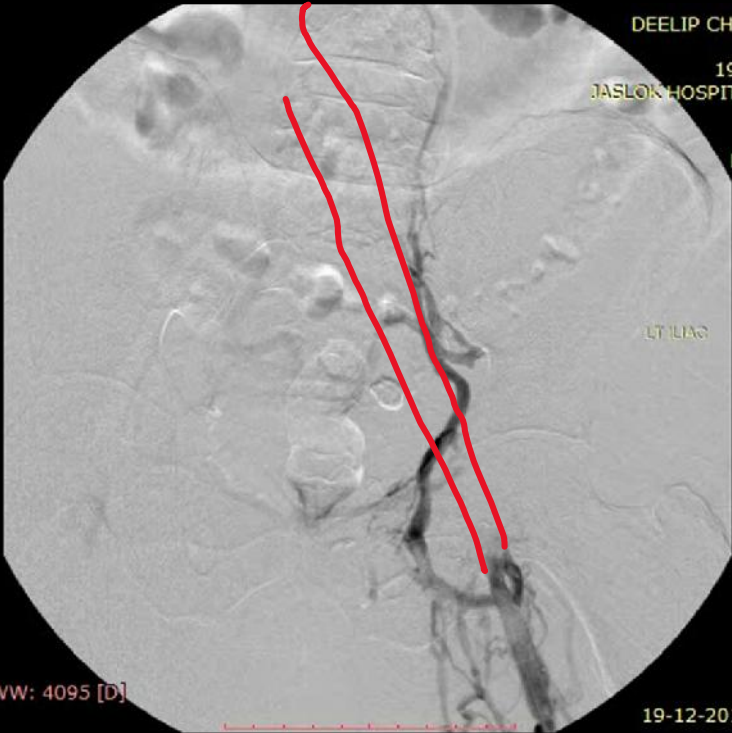
Im: 1/2  
Se: 3

# Venography picture shows a fully blocked Left Iliac vein in the groin

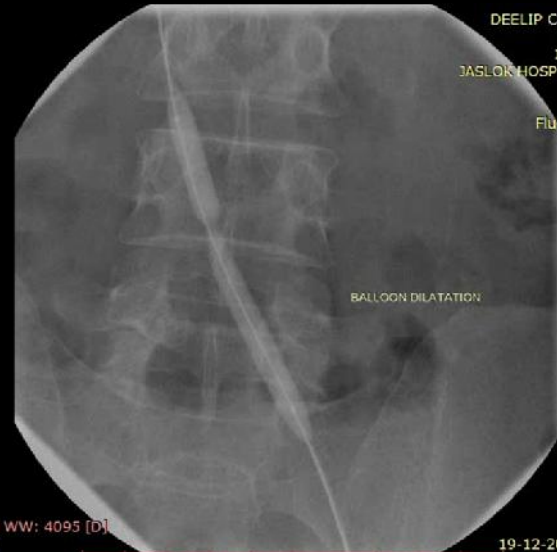
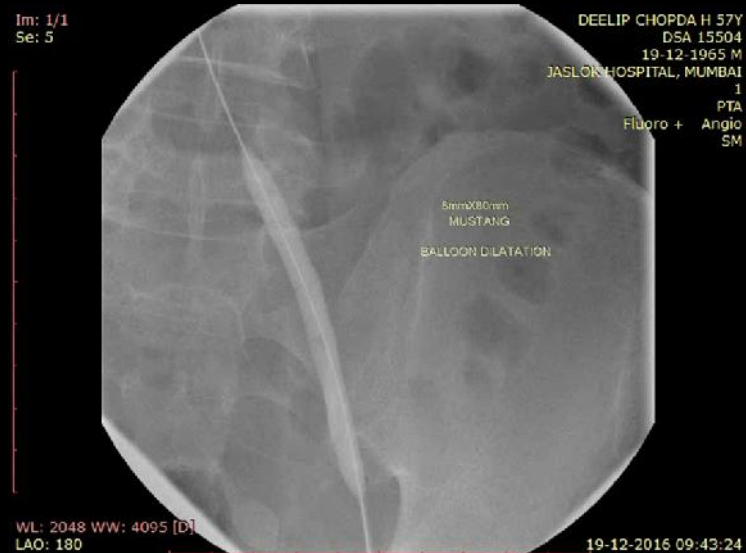
Im: 1/1  
Se: 8

A wire is used to cross the blockage and balloon is used to dilate ( expand ) the blockage and create a passage for the blood

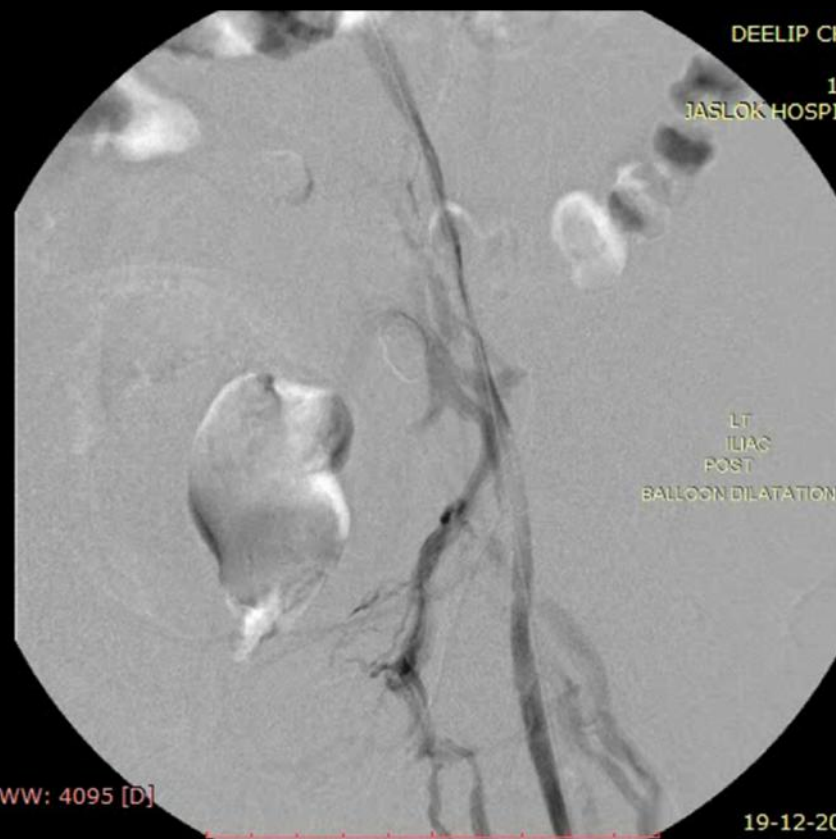
Im: 1/3  
Se: 10

Following the balloon dilatation, a channel is now created in the previously blocked left iliac vein

LT  
ILIAC  
POST  
BALLOON DILATATION

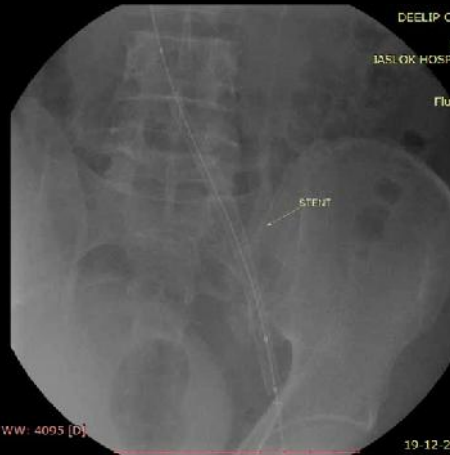
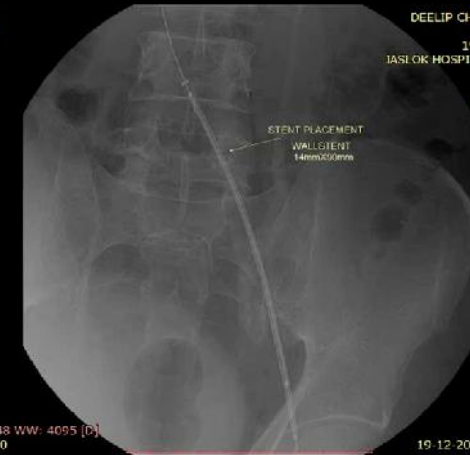
Im: 1/1  
Se: 19

A Metallic Stent is now placed across the blockage, and opened up, to fully expand the vein

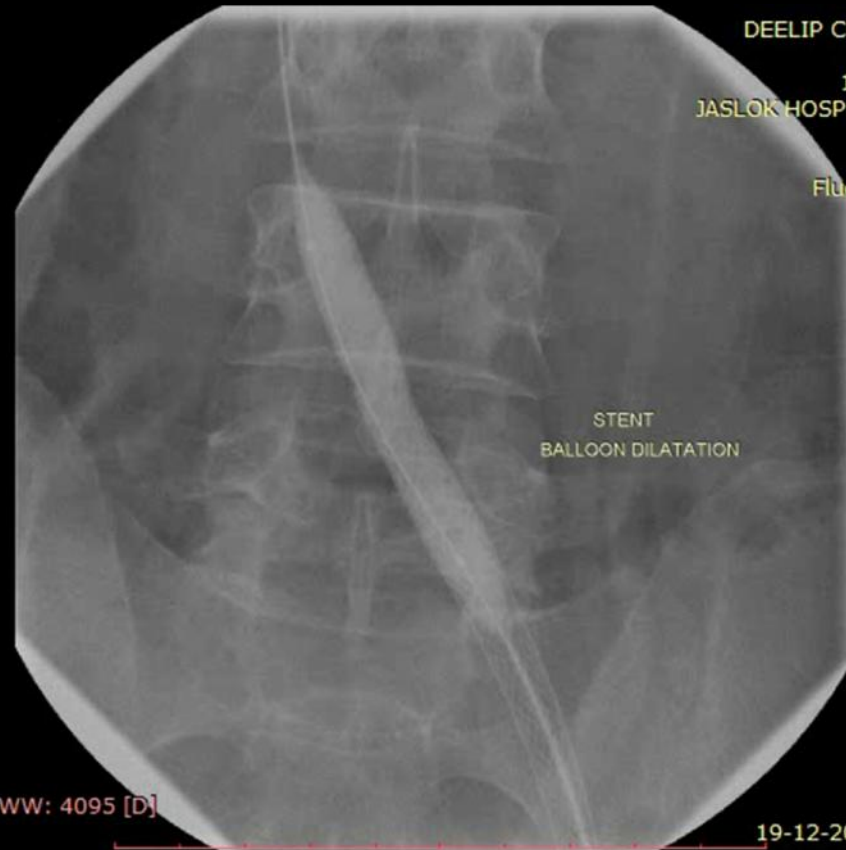
Im: 1/1  
Se: 20

The stent is then expanded by a balloon, so the stent is now fully opposed to the vein wall

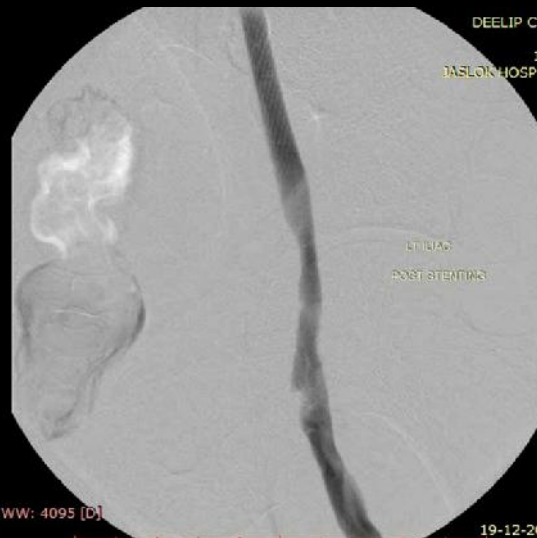
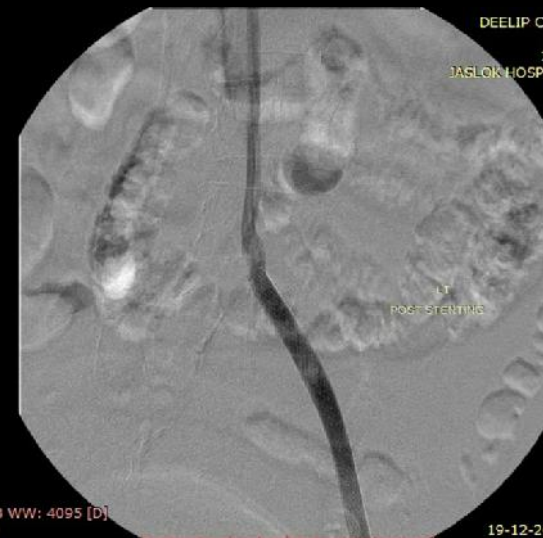
Im: 1/2  
Se: 31

Final  
venography  
picture shows  
fully opened  
up Left Iliac  
Vein
